MASTER INSPECTIONS, LLC

PRE-DRYWALL INSPECTION

1234 Main Street
North Augusta, SC 29860

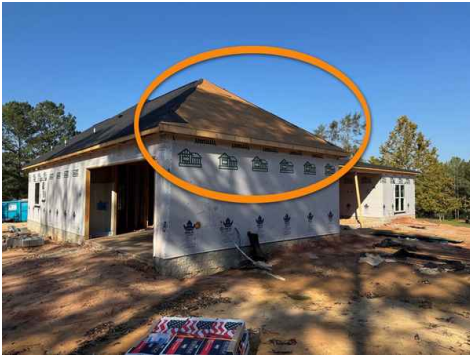
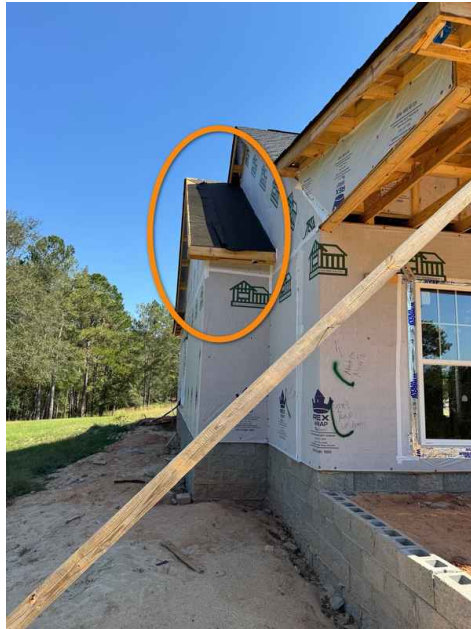
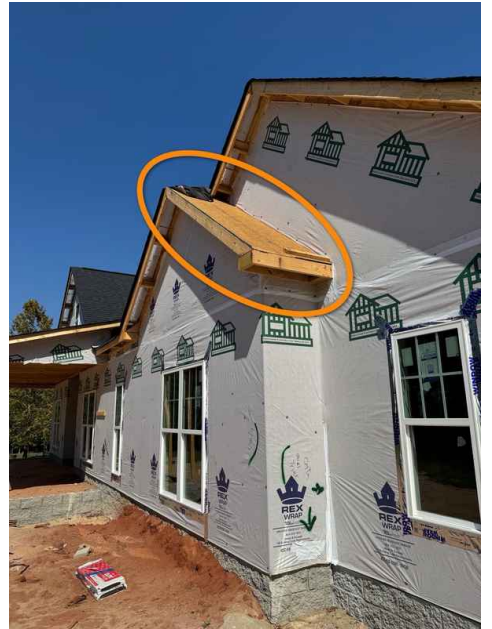
MISSING/DAMAGED SHINGLES

Damaged and/or missing asphalt composition shingles were noted at the time of the inspection. We recommend to replace missing/damaged shingles to avoid damage to the underlying home structure from moisture intrusion.

Contact your builder.

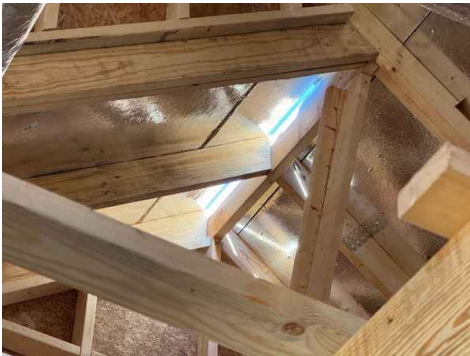
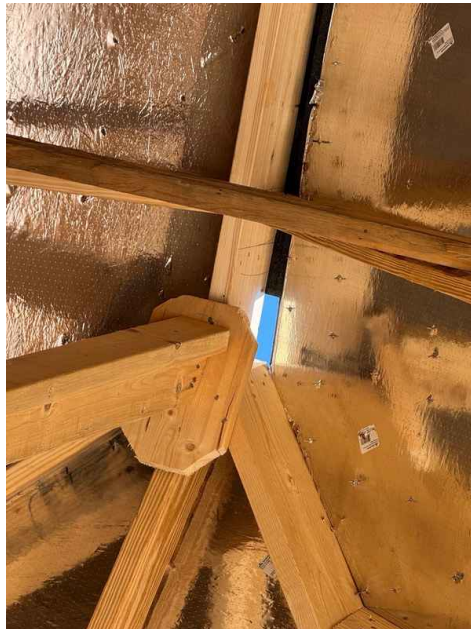
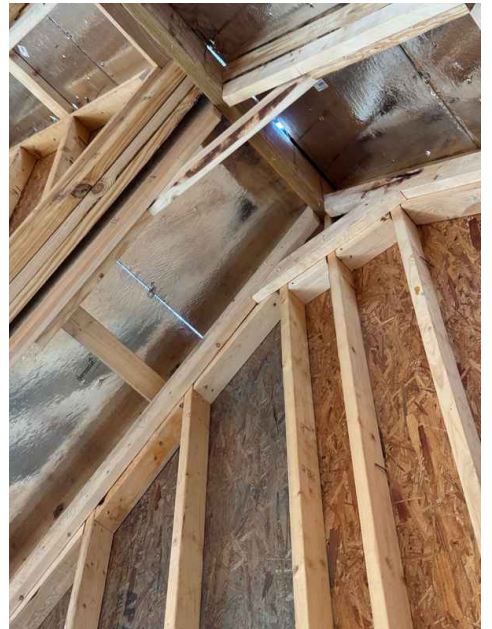
3.2.2 Roof Covering

RIDGE CAP

The Ridge Cap was missing in three locations where missing shingles were observed. This should be corrected when after the sections of roof are shingled.

Contact your builder.

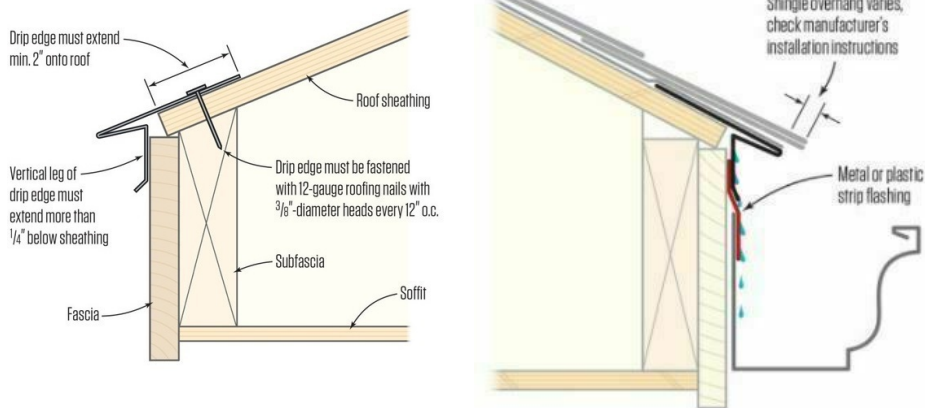
3.4.1 Coverings & Conditions

DRIP EDGE MISSING

During the inspection, it was observed that the drip edge flashing on the roof was missing. Drip edge flashing is a crucial component in the roofing system that helps to direct water away from the eaves and into the gutters. The missing flashing can allow water to seep under the shingles and potentially cause damage to the structure or interior of the building. This issue should be addressed by a qualified roofing contractor to prevent potential water damage.

Contact a qualified roofing professional.

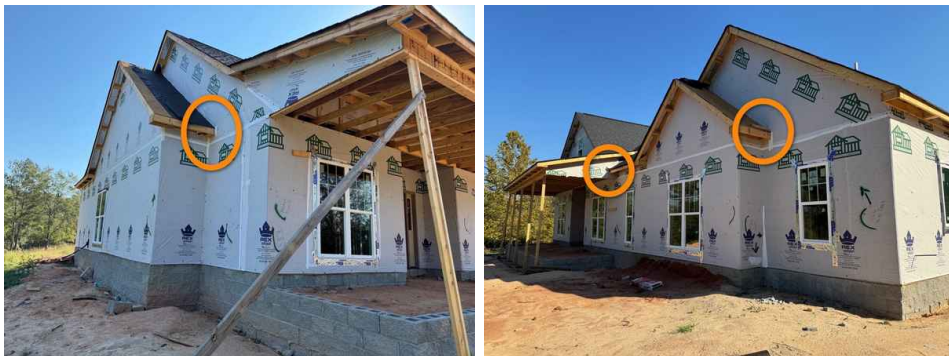
3.5.1 Roof, Chimney, Flashing Installed

KICKOUT FLASHING

There was missing Kick Out Flashing at the time of inspection. Kick out flashing helps direct the water from the sidewall into the gutter system or away from the wall. This can lead to moisture intrusion of the wall structure below this area. The work in this area is still needing to be completed along with the areas of missing shingles. Correction by a qualified roofing contractor is recommended.

Contact your builder.

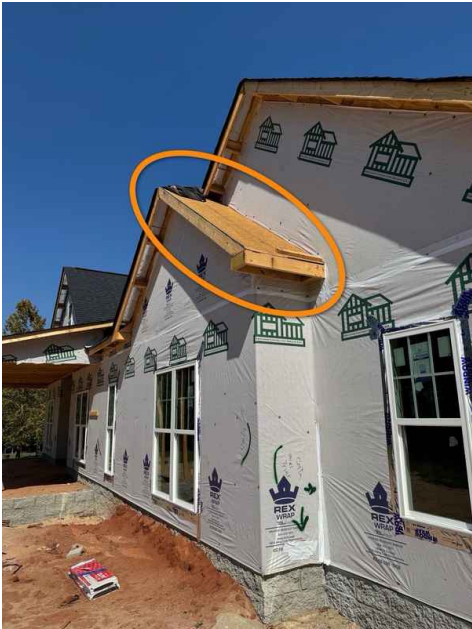
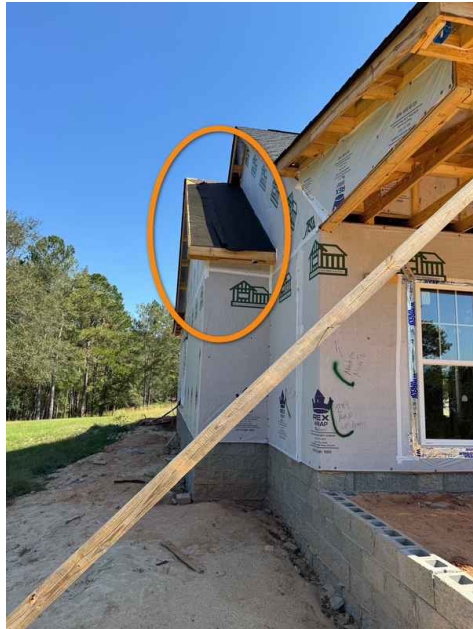
3.5.2 Roof, Chimney, Flashing Installed

SIDEWALL FLASHING

The Sidewall to Roof Flashing is improper at the time of inspection. This can allow moisture intrusion in this area. Proper flashing detail is to have a metal flashing that is behind the siding material down over the roof covering. The work in this area is still needing to be completed along with the areas of missing shingles. Correction by a qualified roofing contractor is recommended.

Contact your builder.

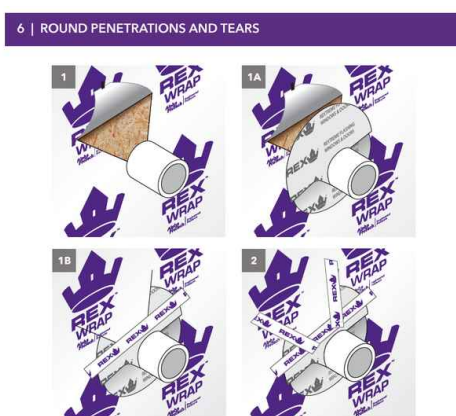
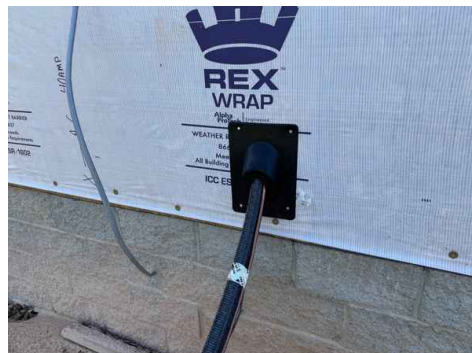
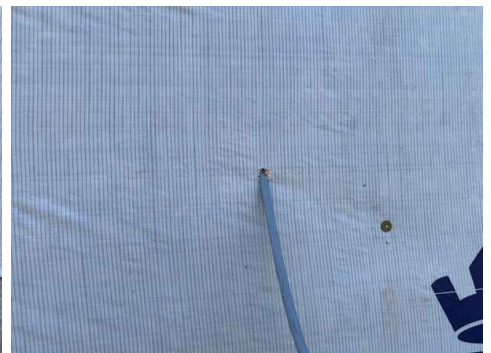
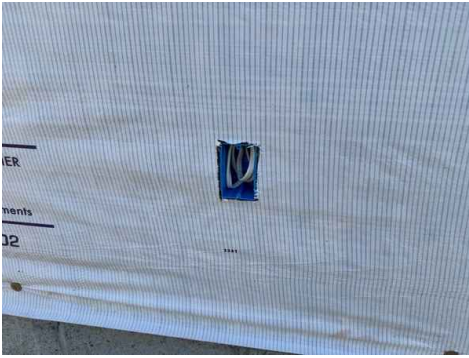
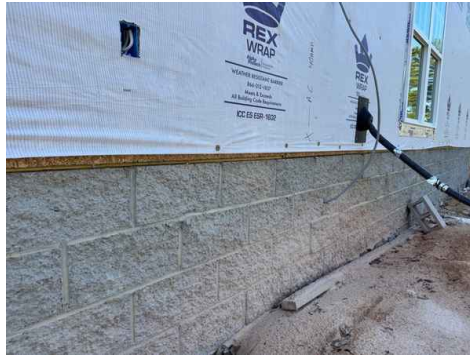
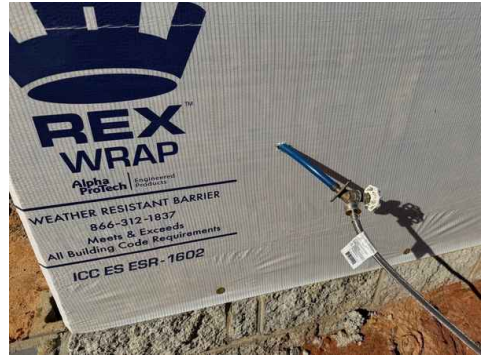
MISSING TAPE

The House Wrap Tape has not been applied around the wall penetrations. We recommend to inspect and install.

Contact your builder.

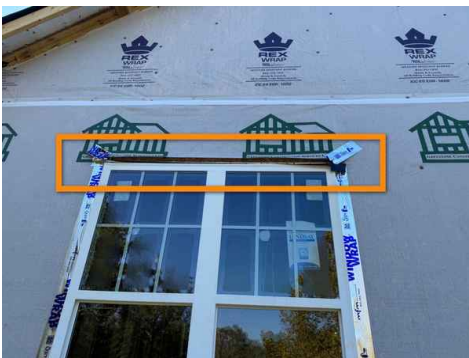
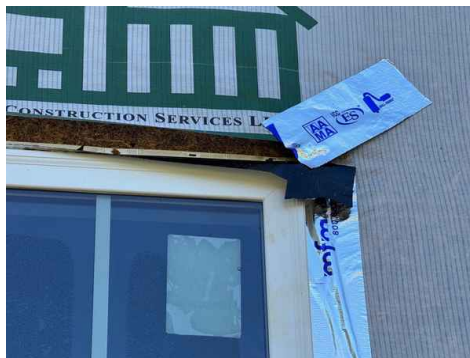
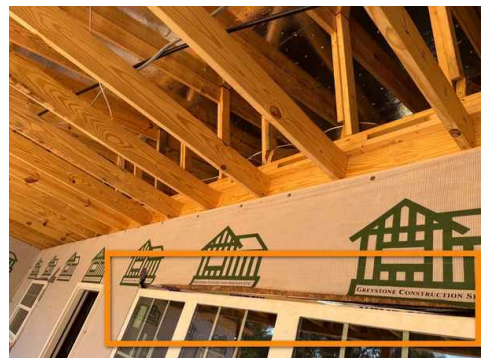
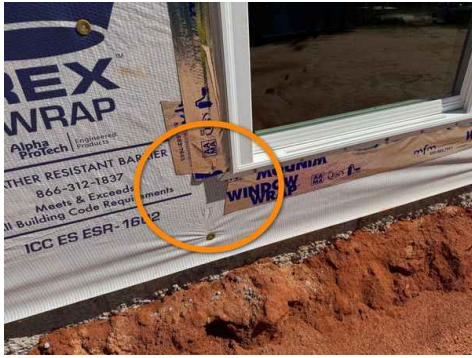
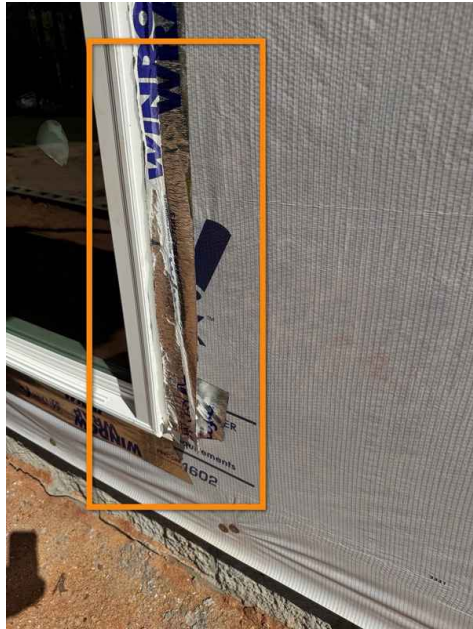
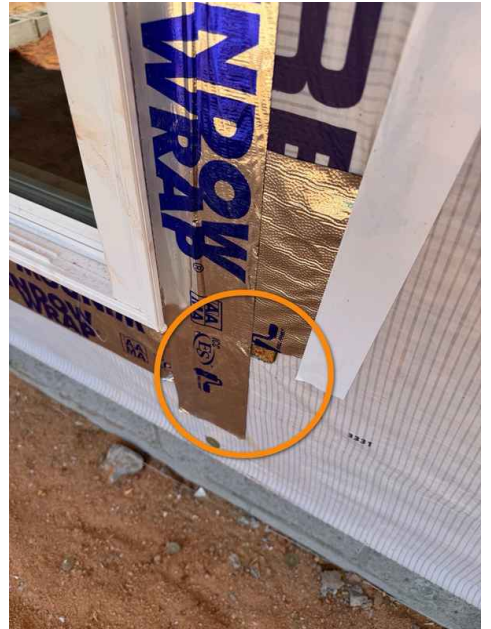
4.5.1 Windows-no cracked broken glass-flashing installed well

WINDOW TAPE

The Flashing Tape around the perimeter of the windows has separated or blown off in more than one location. Correction is recommended prior to siding installation.

Contact your builder.

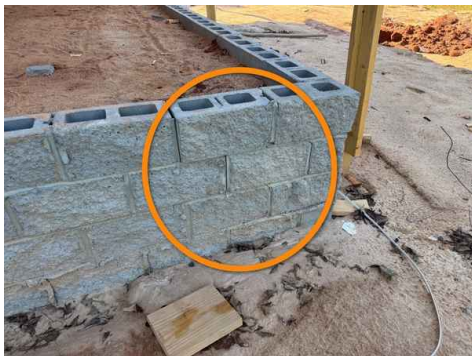
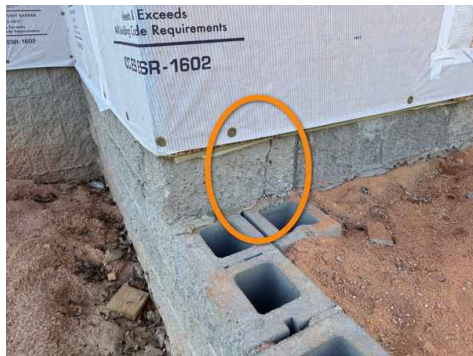
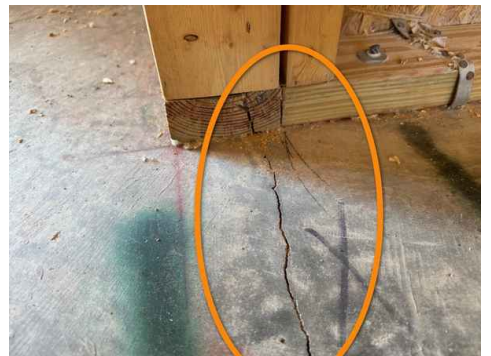
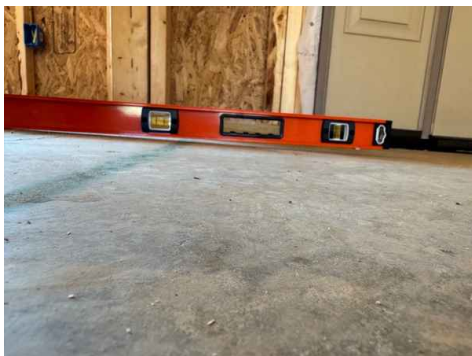
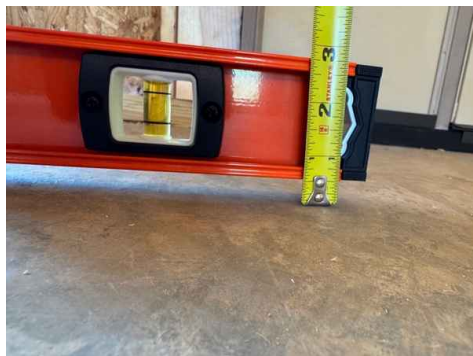
4.8.1 Foundation

CRACK

Several cracks in the foundation were observed. There is one concerning crack that spans from near the front door to the rear of the house. This crack does appear to have approximately 9/16" of displacement over a span of 4'. The front porch on the left side has a few blocks that have been displaced. Further evaluation by the builder is recommended.

Contact a qualified professional.

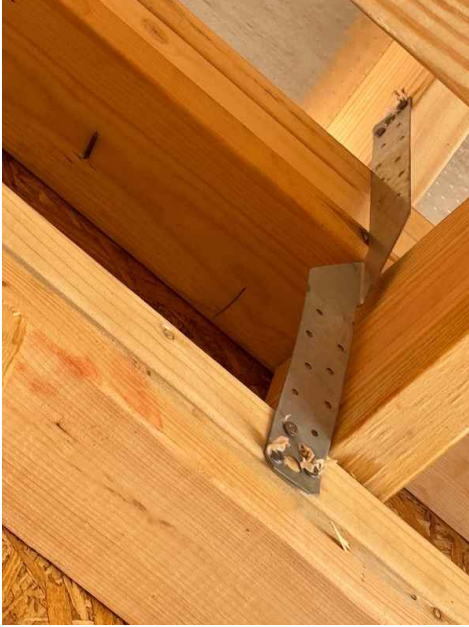
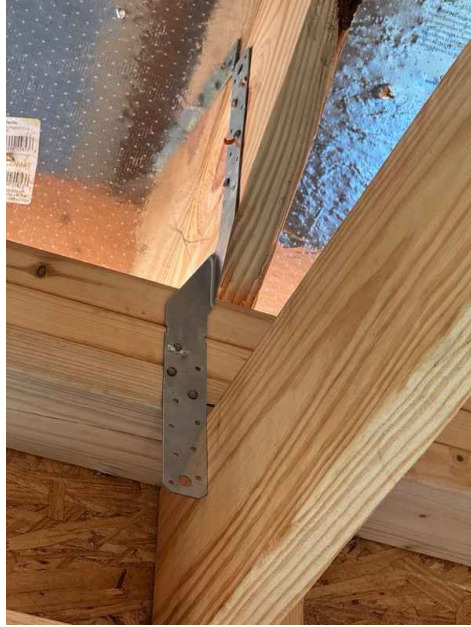
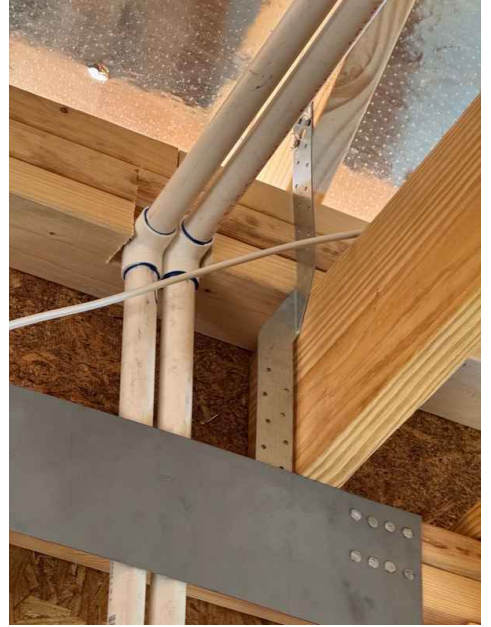
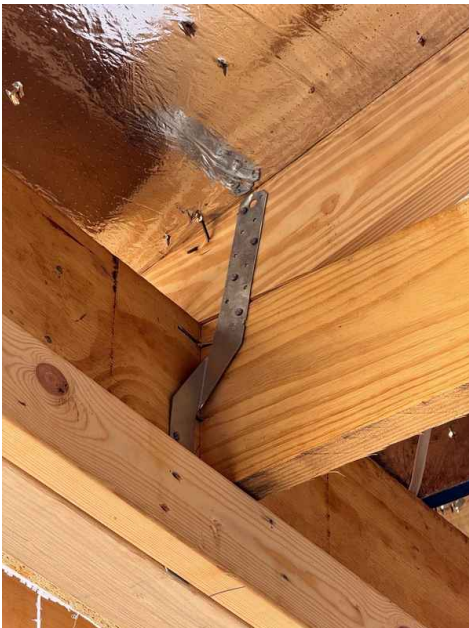
MISSING SUPPORT HANGER NAILS

The Joist Hangers were missing nails at the time of inspection. We recommend to inspect and install. Deadwood/Squash Blocks may need to be installed to actually complete the nailing of the hangers.

Contact your builder.

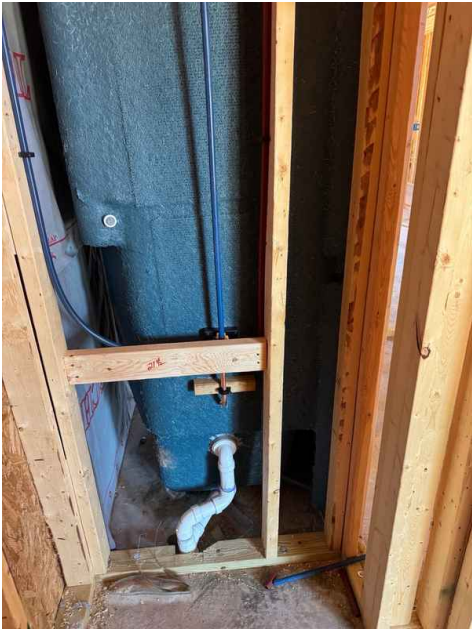
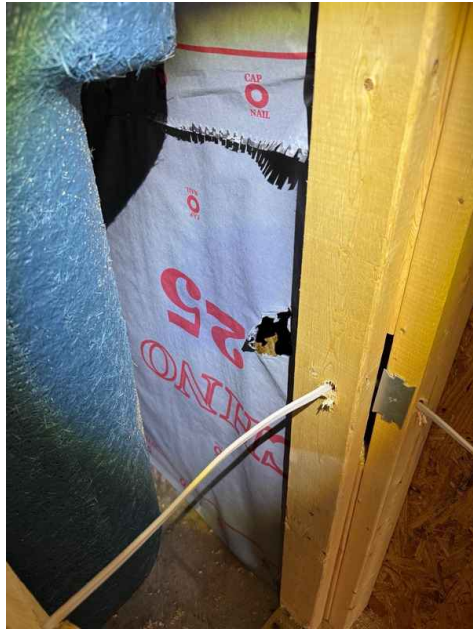
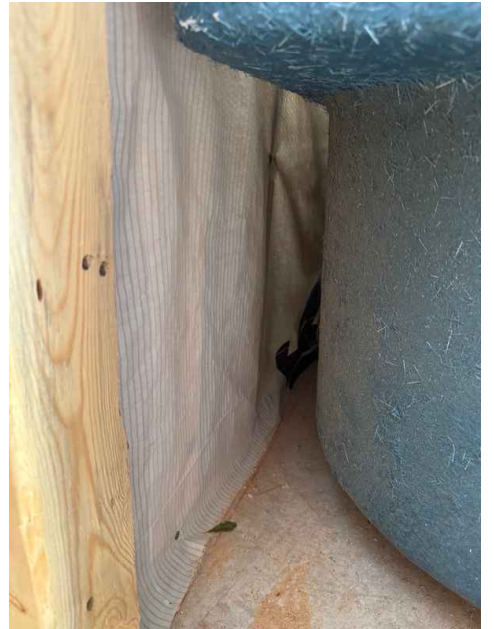
INSULATION: AREA OF MISSING INSULATION

During the inspection, it was identified that there are areas of missing insulation behind the tub and showers. The affected areas did not have any insulation present. Most likely this will be installed when the rest of the house insulation is installed. Missing insulation can lead to increased energy costs and potential issues with temperature regulation within the home. It is recommended that the missing insulation be added prior to drywall installation.

Contact a qualified professional.

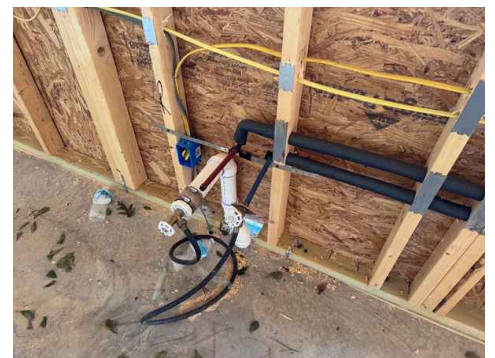
Defect: Missing Plumbing Vent for Kitchen Sink

Implications: Without a vent, the plumbing system may experience slow drainage, gurgling noises, and potential sewer gas odors. This can lead to unsanitary conditions and possible health hazards due to the presence of sewer gases.

Recommendation: While it is possible for the builder to add an air admittance valve (AAV) at this stage, it is not the ideal solution. AAVs can be less reliable over time compared to traditional venting methods. It is advised to have a licensed plumber evaluate and install a proper venting system to ensure optimal drainage and to prevent any potential health risks.

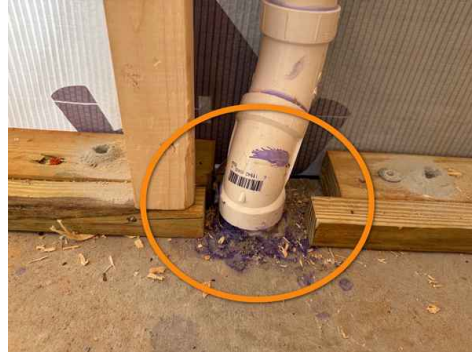
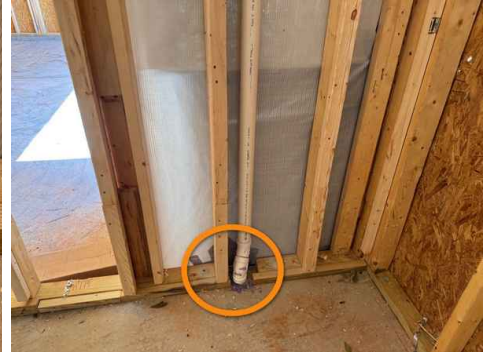
6.6.1 Nail Guards Properly Installed & Secured

NAIL GUARDS

Nail Guards were missing in various locations at the time of inspection. Provided a few reference photos. Builder should inspect entire home and install as per code requirements.

Contact your builder.

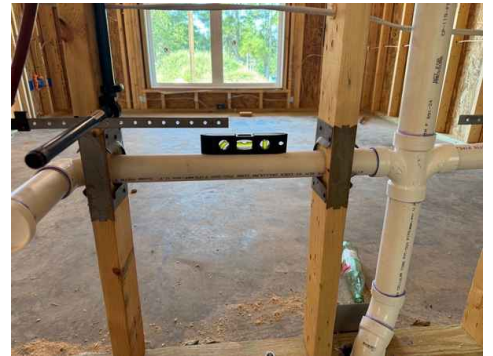
6.8.1 Drains Have Visible Fall

IMPROPER SLOPE

The hall bath left lavatory drain line is not sloped properly. Correction is recommended.

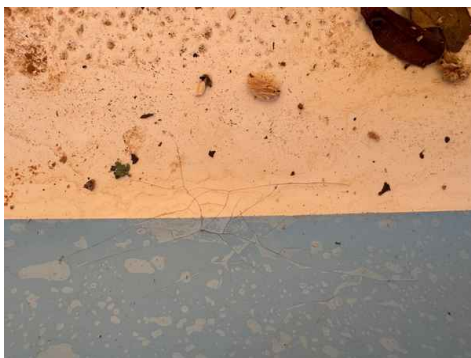
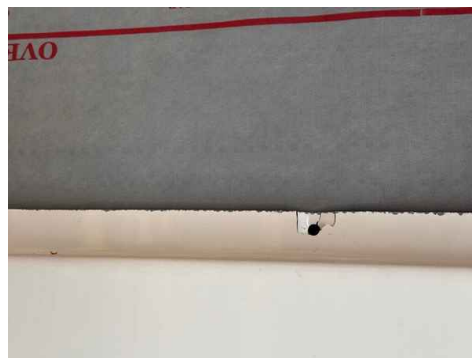
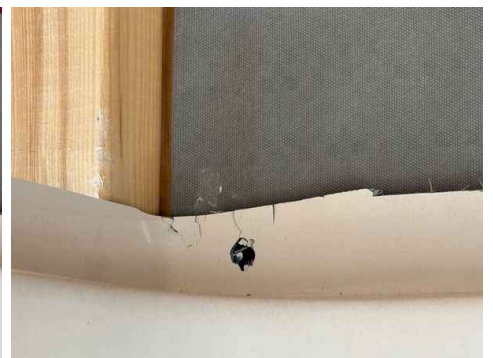
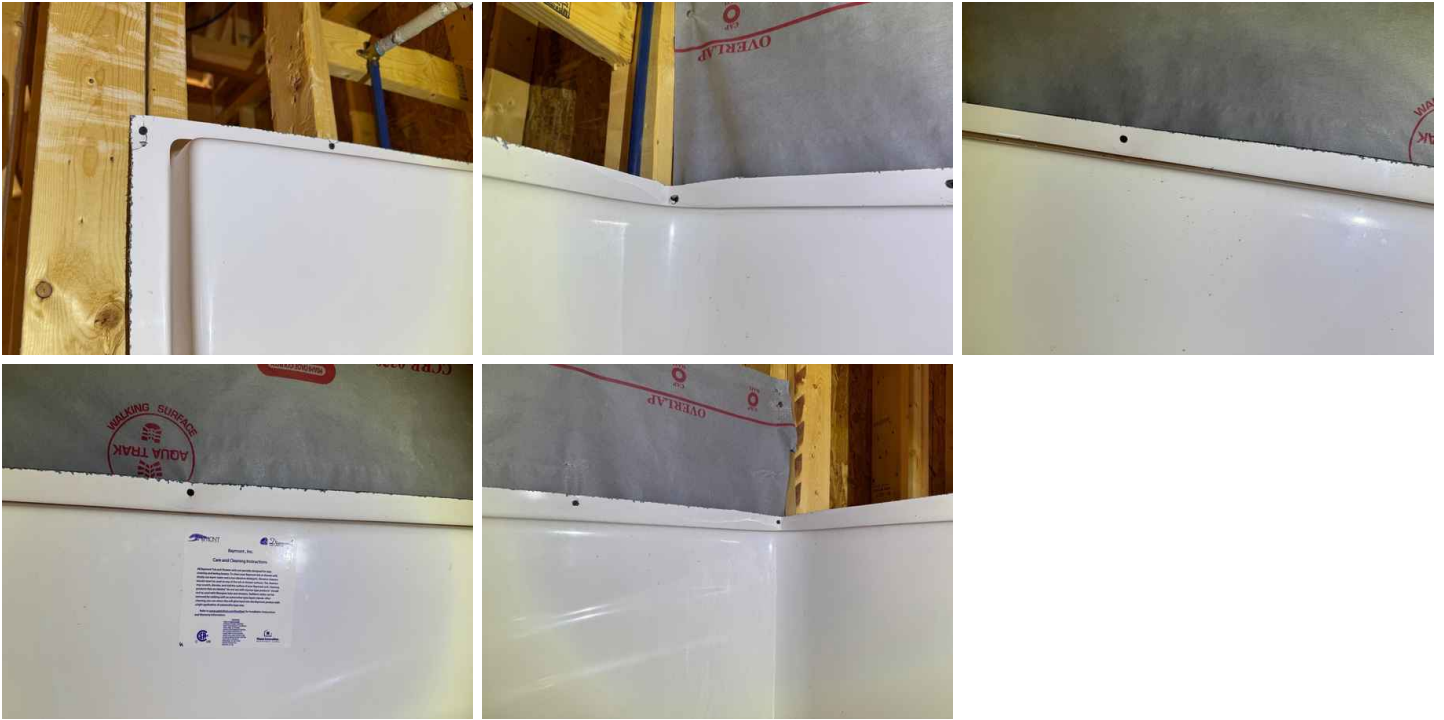
6.9.1 Fixtures

CRACKED OR DAMAGED FIXTURES

One or more tub/shower surrounds were cracked. The shower in the garage will need to be replaced. Multiple nailing flanges were broken and/or missing screws. Evaluation and possible correction by the builder is recommended.

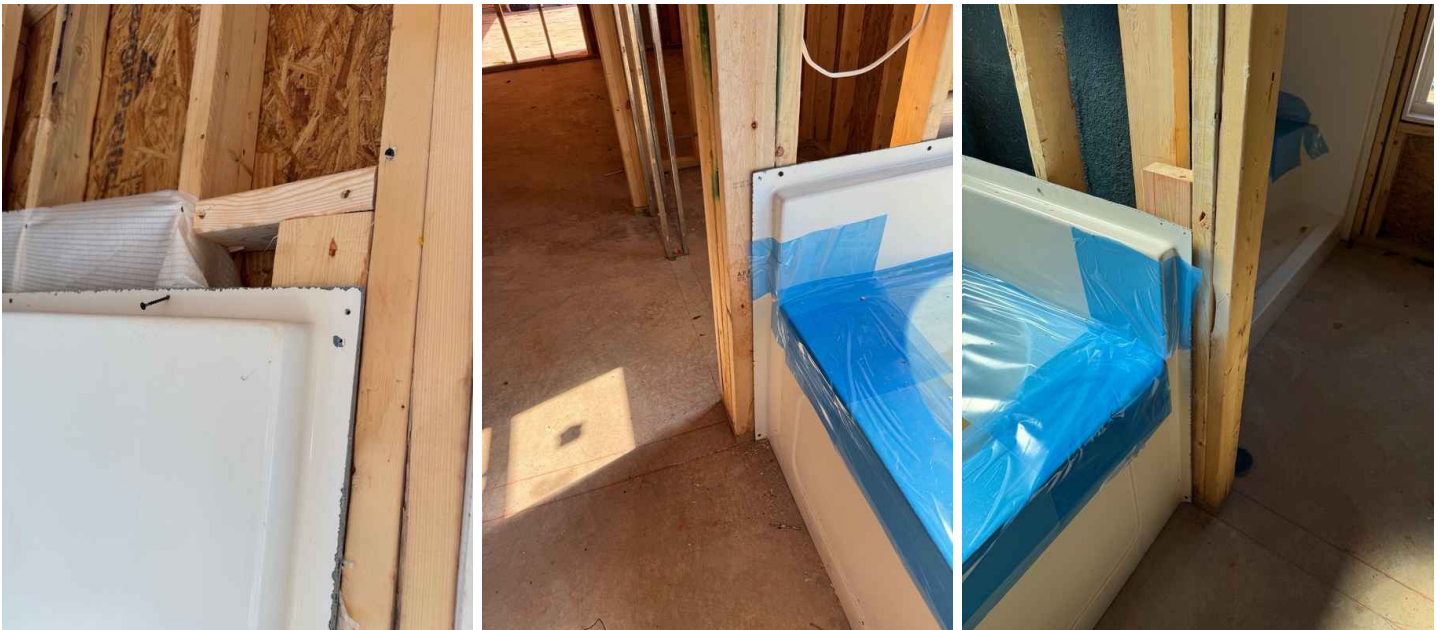
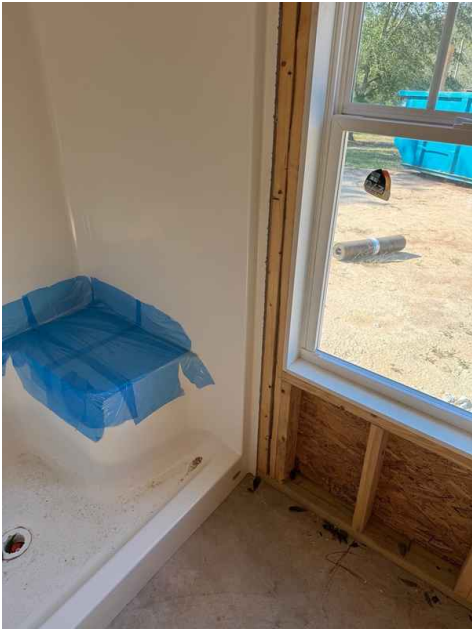
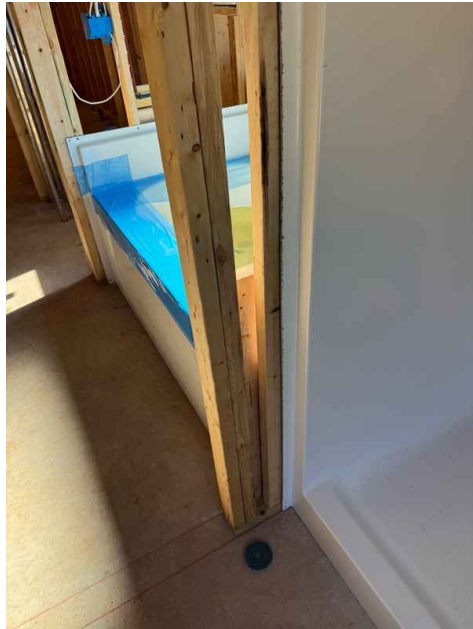
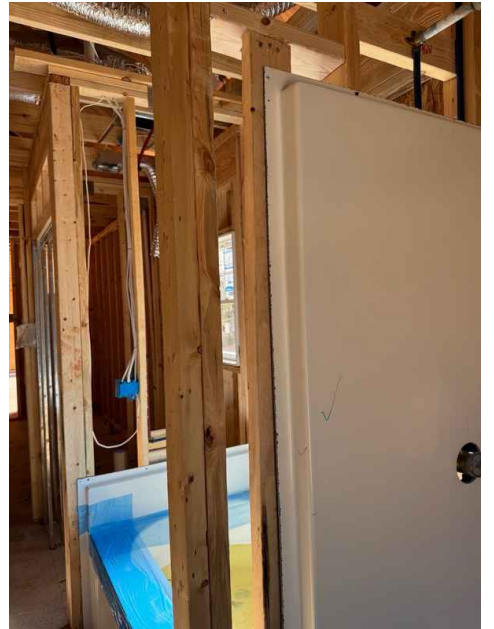
6.9.2 Fixtures

IMPROPER FASTENERS

It appears that the plumbing fixtures are either missing fasteners or were secured with drywall screws. For installing a tub/shower surround, it's recommended to use galvanized or stainless steel screws that are specifically designed for bathroom use. These screws are more resistant to rust and provide a stronger hold. Additionally, many tub surround kits come with their own recommended fasteners, so it's a good idea to follow the manufacturer's instructions for the best results. Evaluation and possible correction by the builder is recommended.

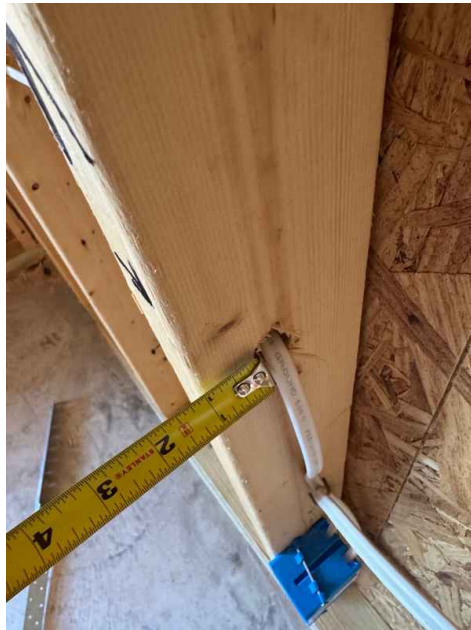
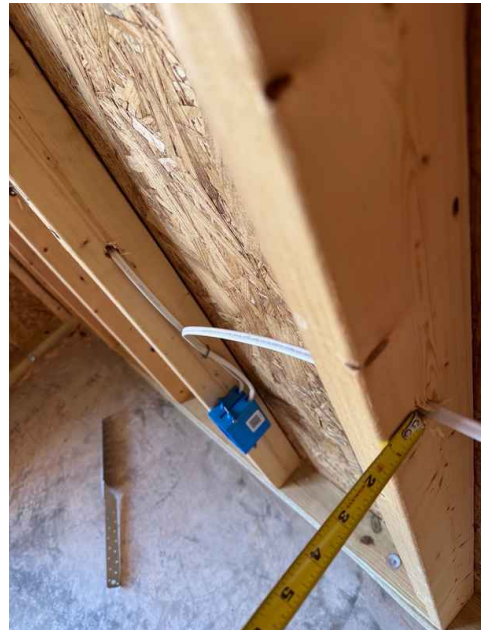
MISSING NAIL GUARDS

Nail Guards were missing in various locations at the time of inspection. Provided a few reference photos. Builder should inspect entire home and install as per code requirements.

Contact your builder.

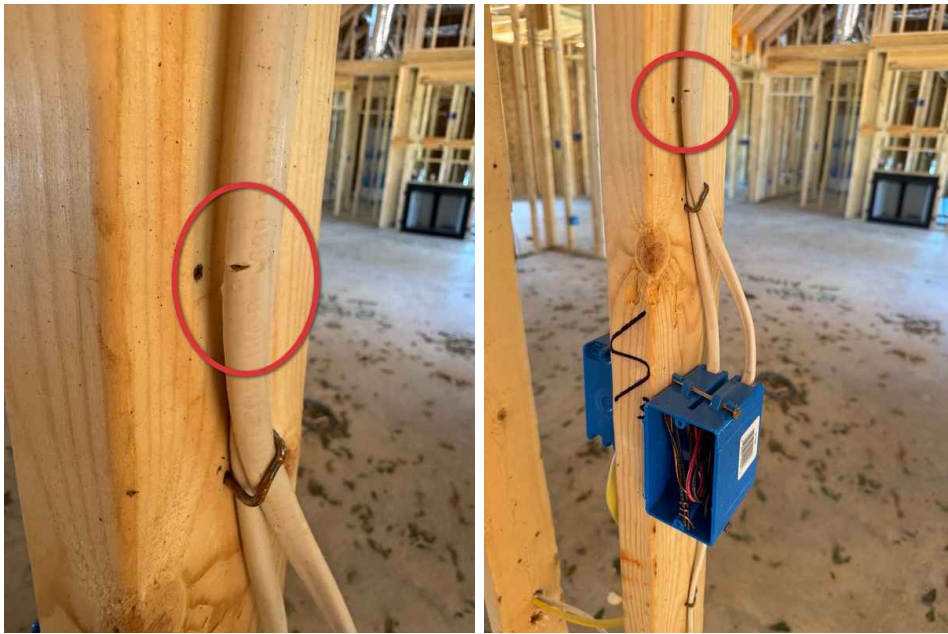
7.3.1 Wiring

Observation: A wire with a cut in its insulation was observed in the Master Bedroom Hall Light Switch. The nick exposes the underlying conductor, which can be seen upon close inspection.

Implication: The nick in the wire's insulation compromises its integrity, increasing the risk of electrical shock, short circuits, or fire hazards. Exposed conductors can lead to dangerous conditions, especially in areas where the wire may come into contact with other conductive materials or moisture.

Recommendation: It is recommended to have a licensed electrician inspect and repair or replace the damaged wire. Ensuring all wiring is properly insulated is crucial for maintaining electrical safety and preventing potential hazards.

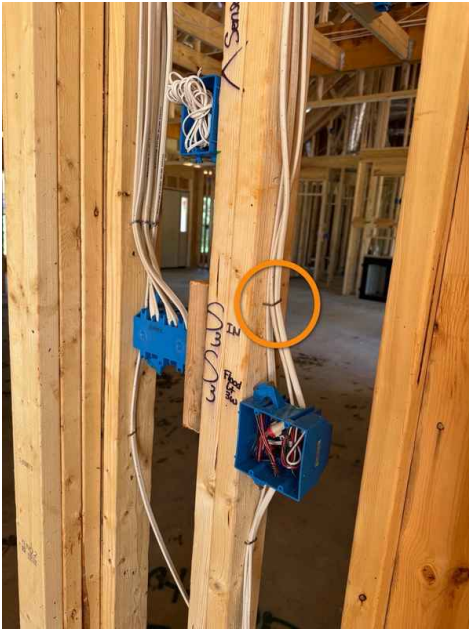
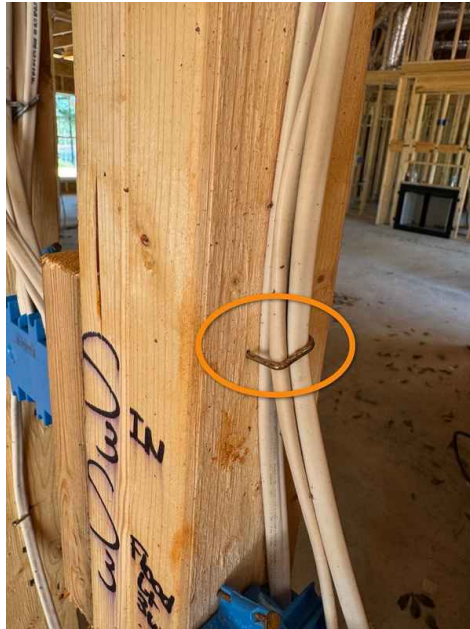
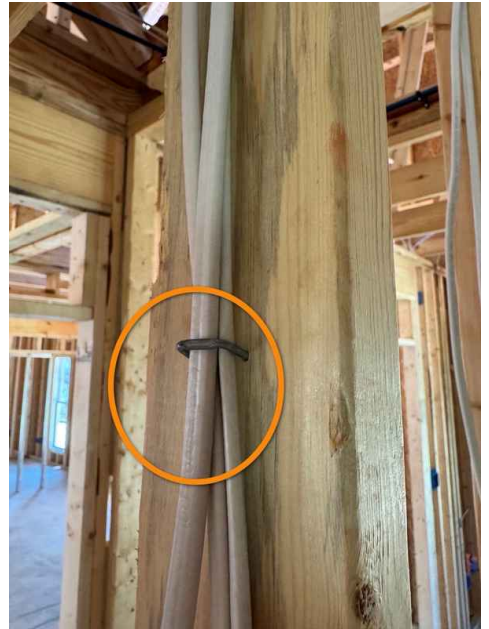
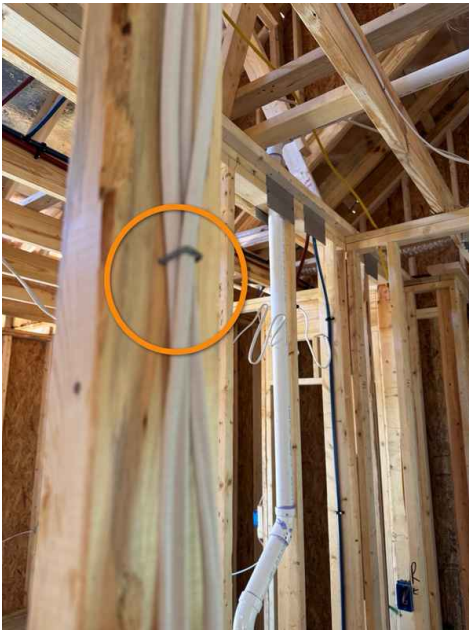
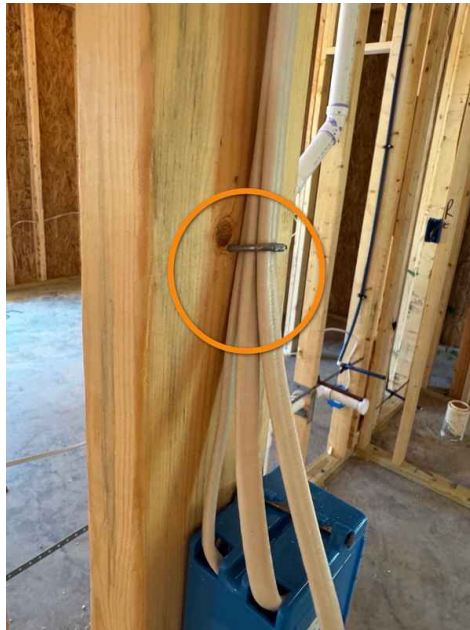
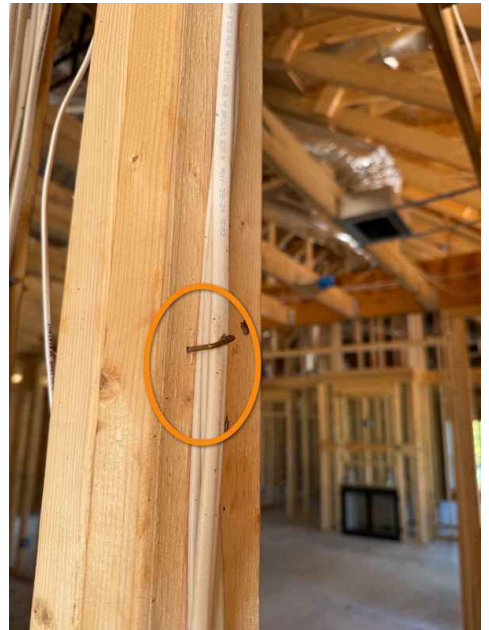
7.3.2 Wiring

Observation: During the inspection, it was noted that multiple electrical wires were secured under a single staple. This condition was observed at the garage light switch, party light switch, office light switch and bedroom #2 light switch.

Implication: Securing too many wires under a single staple can lead to potential damage to the wire insulation, increasing the risk of electrical shorts or fire hazards. This practice does not comply with standard electrical installation guidelines, which typically allow for only two wires per staple to ensure safety and integrity of the wiring.

Recommendation: It is recommended to have a licensed electrician evaluate and correct this condition. The wires should be properly secured using an appropriate number of staples or other approved securing methods to prevent damage and ensure safety.

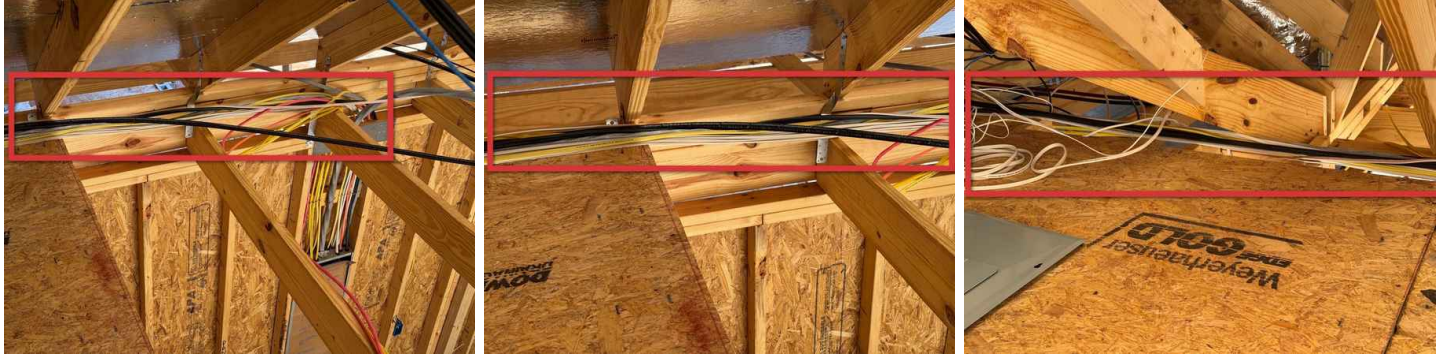
7.4.3 Electrical Deficiencies

Observation: Approximately 17 non-metallic sheathed (NM) cables were observed bundled together and running alongside corrugated stainless steel tubing (CSST) gas pipes in the attic.

Overheating Risk: Bundling multiple NM cables can lead to overheating due to the cumulative heat generated by the cables, which may not dissipate effectively. This can potentially degrade the insulation over time and increase the risk of electrical fires.

Separate the Cables: It is recommended to separate the NM cables to ensure proper heat dissipation and reduce the risk of overheating. This may involve rerouting some of the cables or using additional support to space them apart.

Evaluation by the builder and possible correction recommended.
