MASTER INSPECTIONS, LLC

PRE-DRYWALL INSPECTION

1234 Main Street
North Augusta, SC 29860

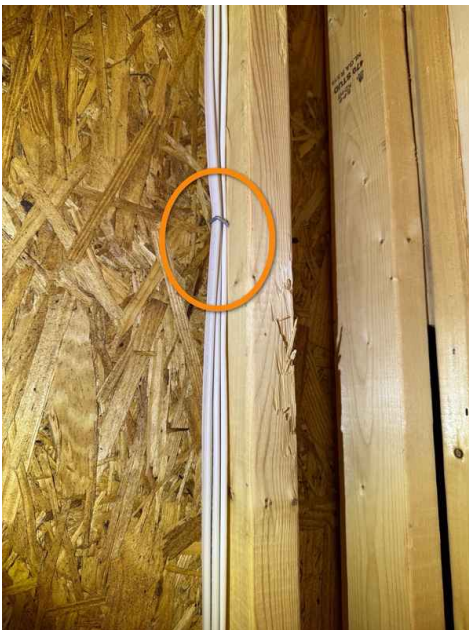
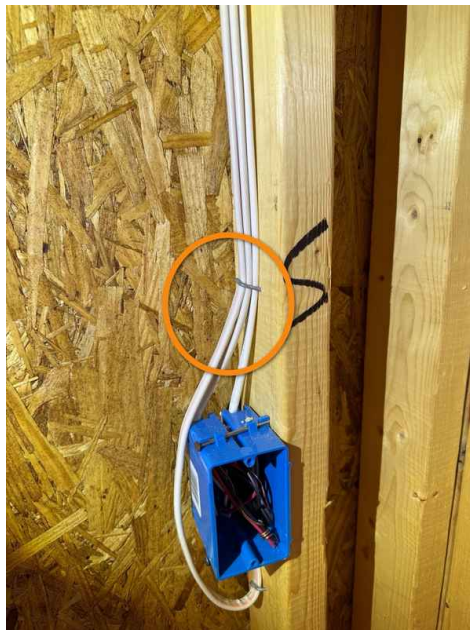
Implication: Securing too many wires under a single staple can lead to potential damage to the wire insulation, increasing the risk of electrical shorts or fire hazards. This practice does not comply with standard electrical installation guidelines, which typically allow for only two wires per staple to ensure safety and integrity of the wiring.

Recommendation: It is recommended to have a licensed electrician evaluate and correct this condition. The wires should be properly secured using an appropriate number of staples or other approved securing methods to prevent damage and ensure safety.
